Republic F-84C “Thunderjet”

Official Report of
Accident
April 30, 1949
Table Rock, Nebraska

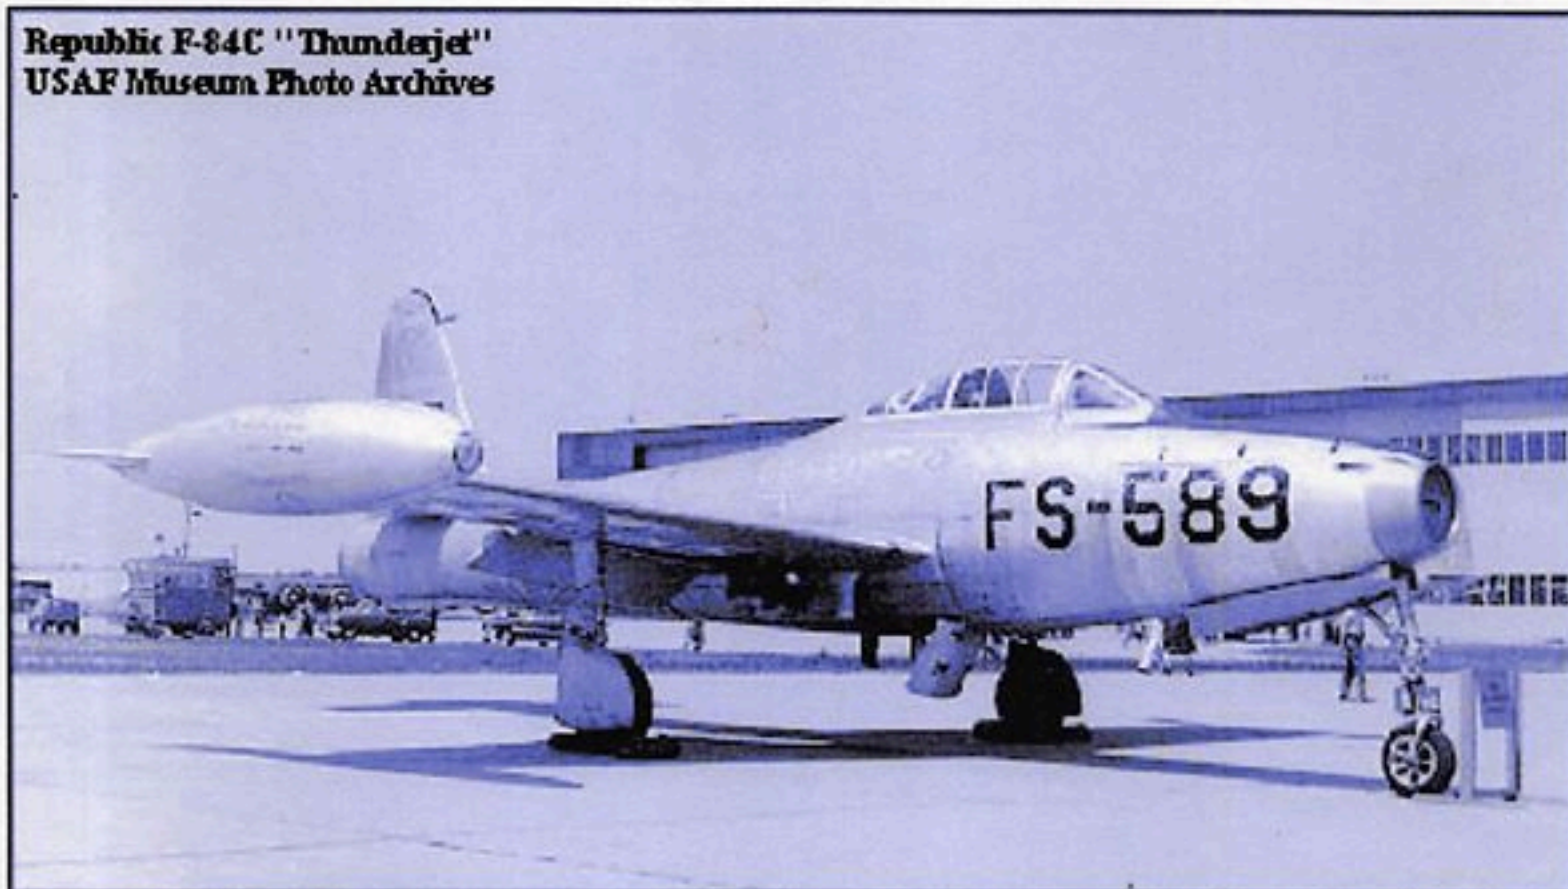
Republic F-84C "Thunderjet"
USAF Museum Photo Archives

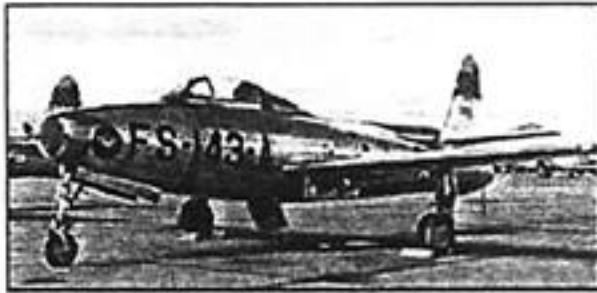
Republic F-84 "Thunderjet"

The F-84, the USAF's first post-war fighter, made its initial flight on February 26, 1946. It began rolling off the production lines in June 1947, and by the time production ceased in 1953, approximately 4,450 "straight-wing" F-84s (in contrast to the swept-wing F-84F) had been built. In addition to being used by the USAF, many were supplied to allied nations

participating in the Mutual Security Program. During its service life, the F-84 became the first USAF jet fighter able to carry a tactical atomic weapon.
